SUMMARY

1234 Main St. Naperville IL 60564

Your Best Home Inspection LLC

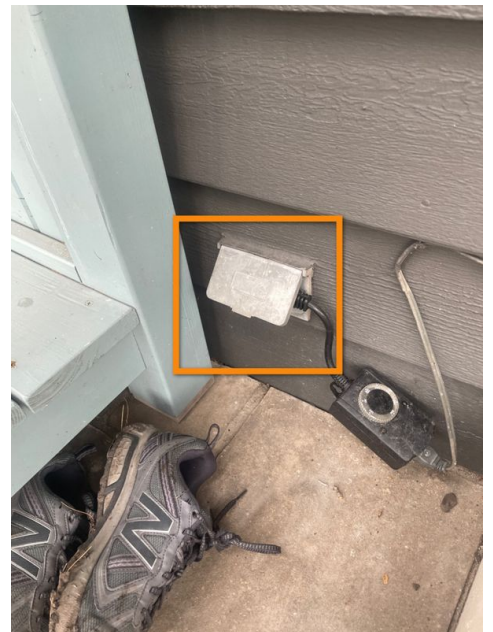
4.5.1 GFCIs & Electrical

LACK OF IN-USE GFCI OUTLET COVERS

Minor Defect

Exterior GFI outlets should be covered with in-use covers so the outlet is protected even when devices are plugged in. Recommend installation of in-use covers.

Recommended DIY Project

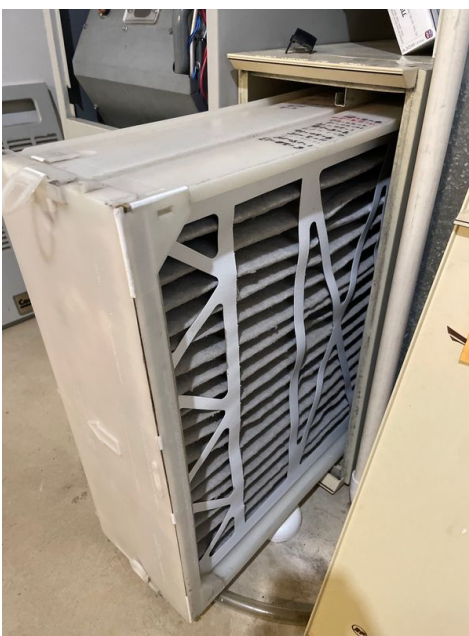
6.1.1 Heating System Information

FILTER DIRTY

Minor Defect

I observed a dirty air filter at the furnace filter. Recommend changing out with a new filter every 30 days.

Recommended DIY Project

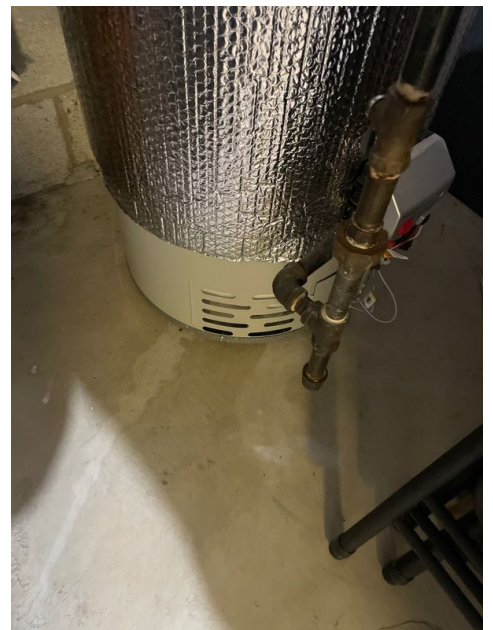
8.3.1 Hot Water Source

MISSING CATCH PAN UNDER TANK

I observed that the hot water tank is missing a water leak catch pan.

Contact a qualified professional.

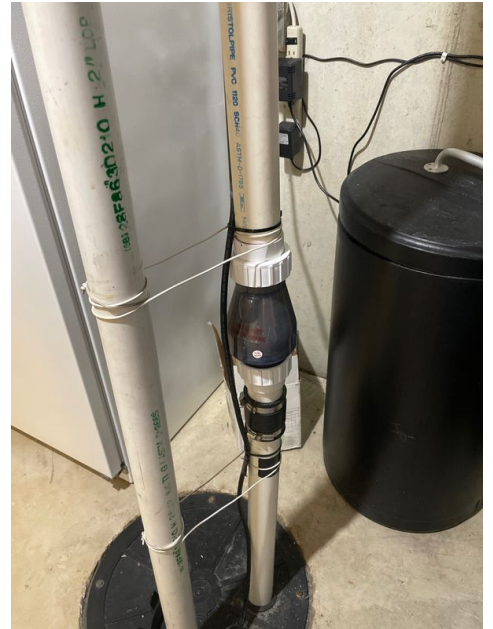
8.4.1 Drain, Waste, & Vent Systems

EJECTOR PIT SHUT-OFF VALVE

Minor Defect

It was observed that the ejector pit does not have a shut-off valve above the check valve. A shut off valve is recommended for servicing the check valve and/or ejector pit equipment.

Contact a qualified professional.

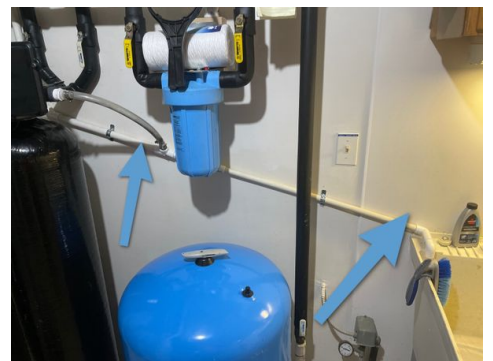
8.5.1 Water Supply & Distribution Systems

WATER SOFTENER DRAIN FEEDS INTO SEPTIC FIELD

Minor Defect

The water softener discharge hose drains into the septic drainage system of the house. The high salt content of the discharge water can negatively affect the efficiency of the septic system.

Contact a qualified professional.

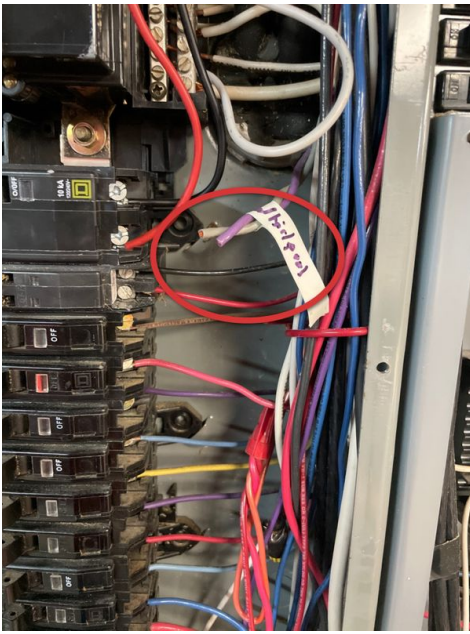
9.5.1 Panelboards & Breakers

CABLE CONNECTOR DEFECT

Minor Defect

I observed a defect at the electrical cable connector at the panelboard. any disconnected wiring should have the wires capped with twist-on electrical connectors.

Contact a qualified electrical contractor.

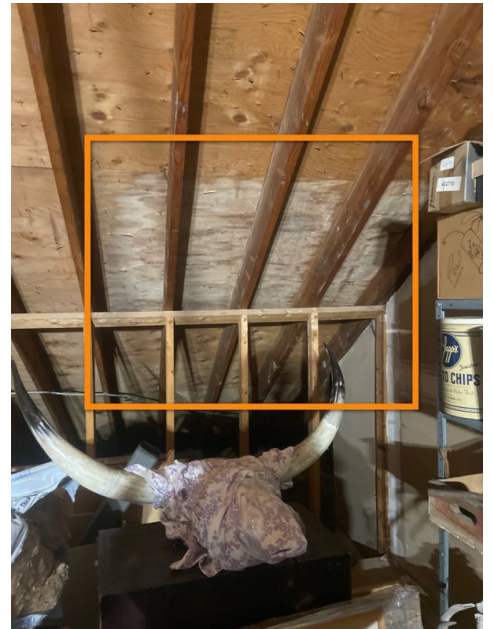
10.1.1 Structural Components & Observations in Attic

Minor Defect

PRIOR WATER PENETRATION OBSERVED

I observed indications that sometime in the past there was water penetration or intrusion into the attic. Water marks were observed. Correction and further evaluation is recommended.

Recommend monitoring.

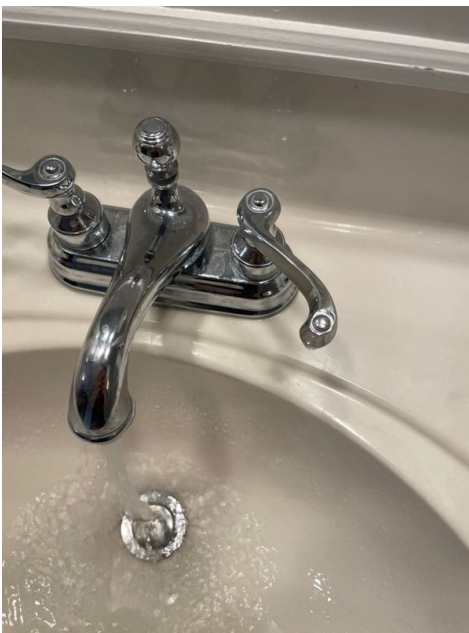
11.2.1 Sinks, Tubs & Showers

DAMAGE AT FIXTURE

Material Defect

I observed damage at the fixture. The Coldwater handle of the faucet only travels half of its available travel. This is likely due to a worn out cartridge valve. Recommend replacing cartridge valve.

Contact a qualified plumbing contractor.

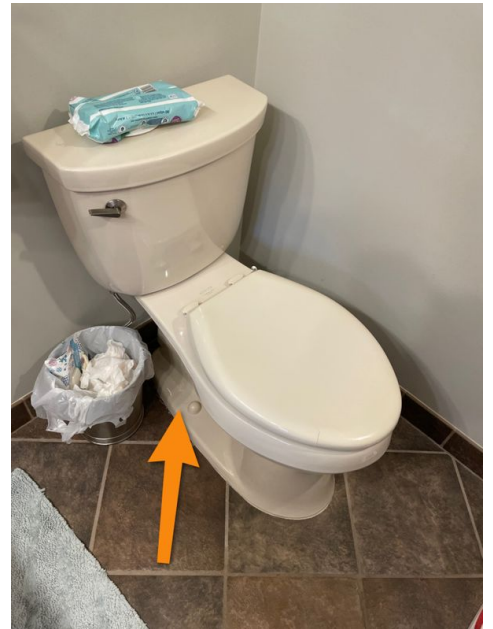
12.1.1 Bathroom Toilets

LOOSE TOILET FLANGE CONNECTION.

Major Defect

A toilet was observed to have a loose connection to the floor system. It is likely that the wax ring seal has been compromised. Recommend sourcing a licensed plumber to reset the toilet.

Contact a qualified professional.

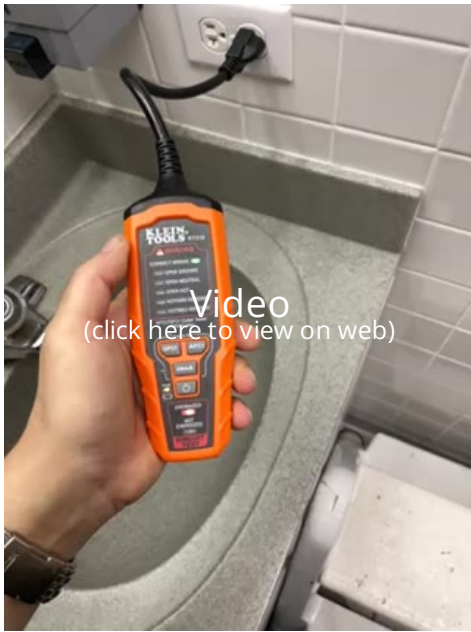
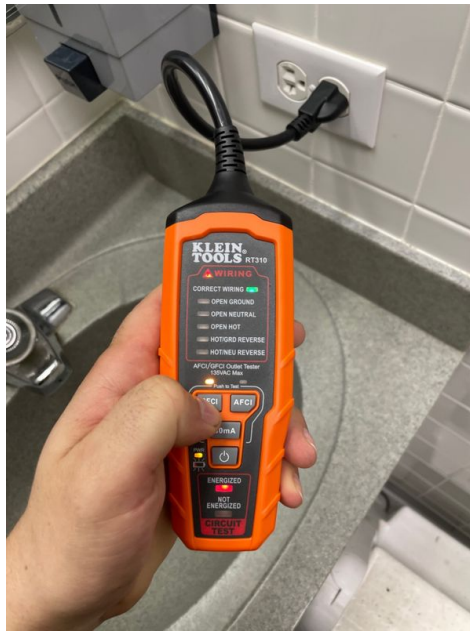
14.4.1 GFCI & Electric in Bathroom

RECEPTACLE IS NOT GFCI PROTECTED

Major Defect

I observed that the receptacle in the bathroom is not testing as being GFCI protected. This is a hazardous condition. Recommend replacing outlet with GFCI protected outlet.

Contact a qualified electrical contractor.

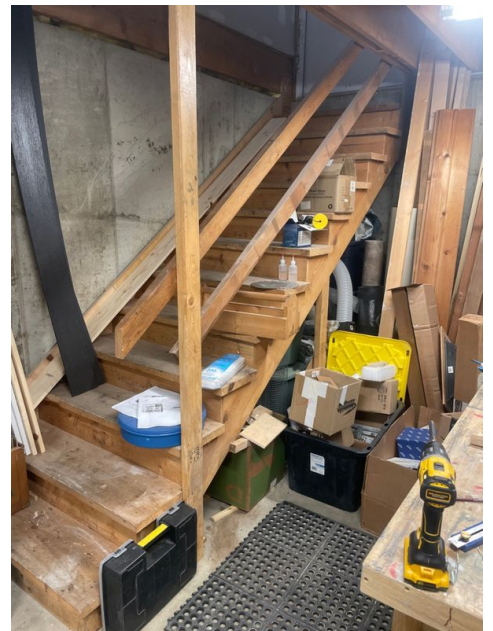
15.5.1 Stairs, Steps, Stoops, Stairways & Ramps

MISSING HANDRAIL

Major Defect

I observed a missing handrail on the stairs to the unfinished basement from the garage.

There is more than one step here, and I recommend installing a handrail for safety.

Contact a qualified carpenter.

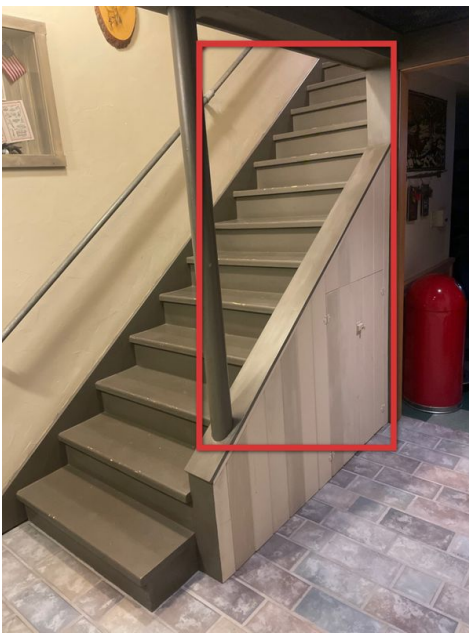
15.5.2 Stairs, Steps, Stoops, Stairways & Ramps

MISSING GUARDRAIL

Minor Defect

The basement stairs are missing a guard rail system on one side. This represents a Hazard as children and adults could step off the side.

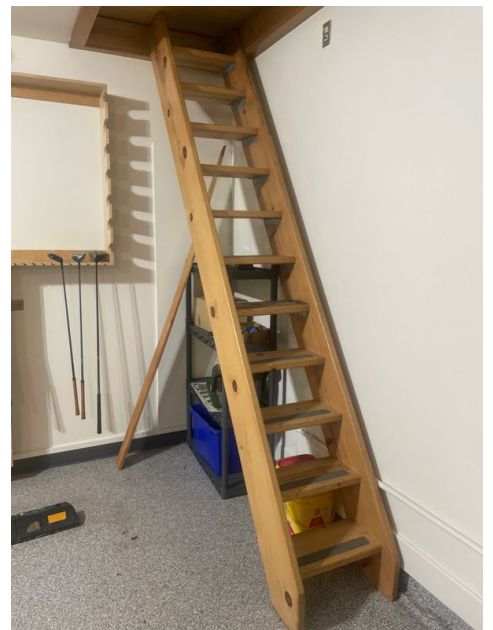
15.5.4 Stairs, Steps, Stoops, Stairways & Ramps

IMPROPER STAIRWAY TO GARAGE ATTIC.

The stairway/ladder to the garage attic access does not meet any code requirements besides tread length. Riser height is too tall, missing riser plates, no handrail, no guard rail, width too narrow. Homeowner should use at their own risk. This is an unsafe condition.

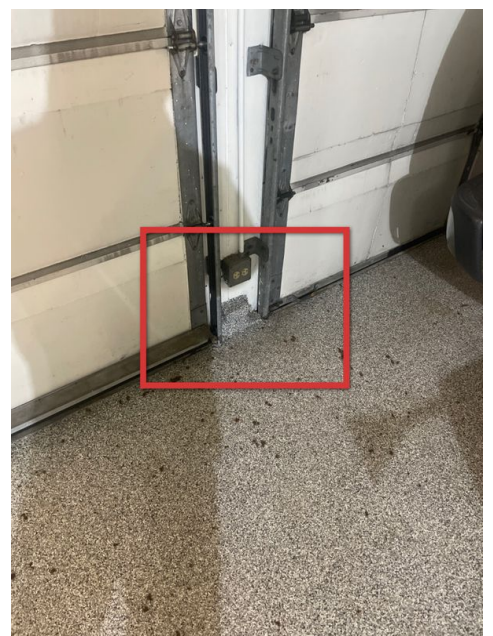
17.3.1 Garage Vehicle Door Opener

PHOTO ELECTRIC EYES NOT PRESENT

The photo electric eyes were not present on either garage door. These are a safety device that stops the garage door from closing if someone or something crosses in the doors path. Recommend installing new photo electric eye sensors.

Recommendation
Contact a qualified professional.

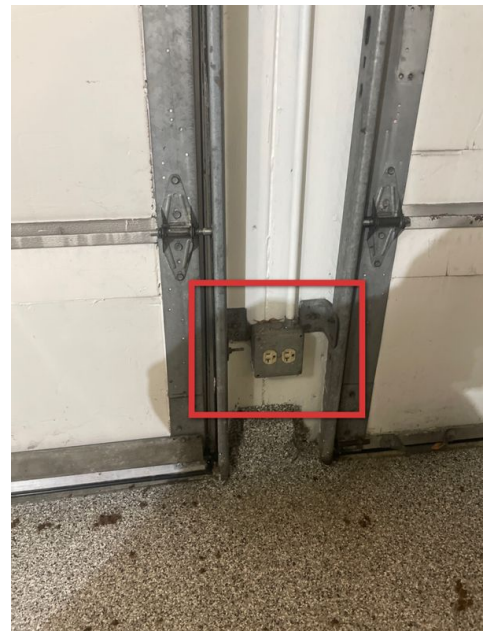
17.4.1 Electric in Garage

MISSING GFCI-PROTECTION IN GARAGE

Major Defect

I observed a receptacle in the attached garage without GFCI (or ground fault circuit interrupter) protection.

GFCI protection is required for all 15- and 20-amp receptacles, including outlets for refrigerators, garage door openers, and washing machines.

Contact a qualified electrical contractor.

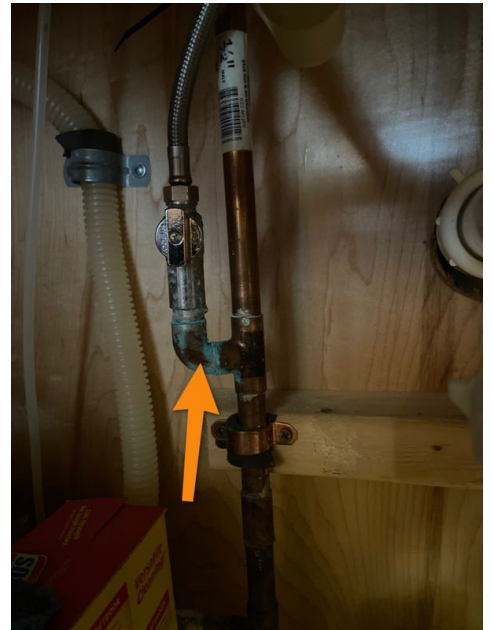
18.1.1 Kitchen Sink

DEFECT AT THE KITCHEN SINK

Minor Defect

I observed indications of a defect at the kitchen sink. The soldered connection for the hot water supply may have a slow leak indicated by presence of oxidation. This can also be caused by flux being left on the joint after the soldering process. Recommend monitoring for further leakage.

Recommendation
Recommended DIY Project

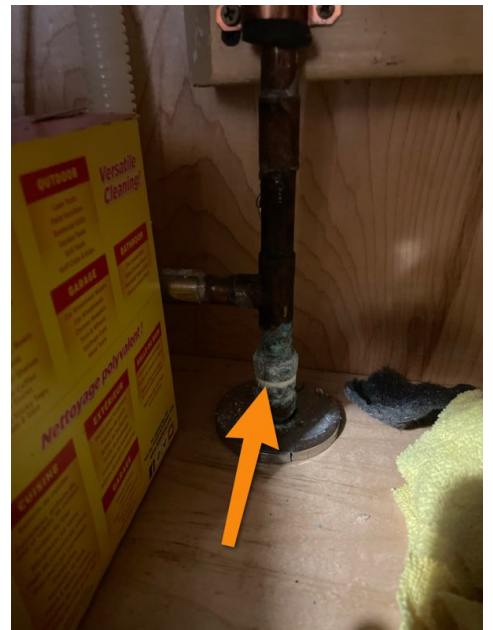
18.1.2 Kitchen Sink

DEFECT ON HOT WATER SUPPLY LINE. #2

Minor Defect

Compression fitting on copper hot water supply line has slow leak causing corrosion and oxidation. This leak should be repaired before it forms pinholes and becomes an active leak. Recommend hiring a plumbing contractor to perform repair.

Recommendation
Contact a qualified plumbing contractor.
