# YOUR BEST HOME INSPECTION LLC

630-955-6618

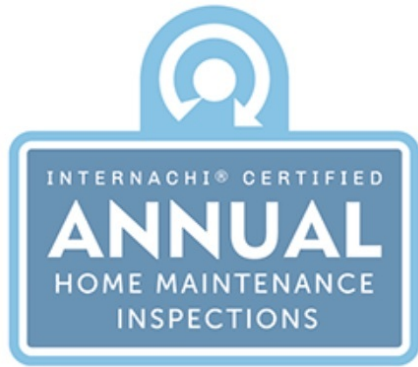
Even the most vigilant homeowner can, from time to time, miss small problems or forget about performing some routine home repairs and seasonal maintenance. That's why an Annual Home Maintenance Inspection will help you keep your home in good condition and prevent it from suffering serious, long-term and expensive damage from minor issues that should be addressed now.

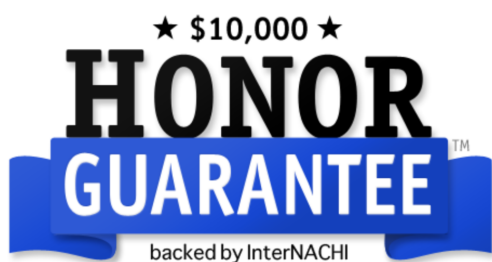
InterNACHI is so certain of the integrity of our members that we back them up with our **\$10,000 Honor Guarantee**.

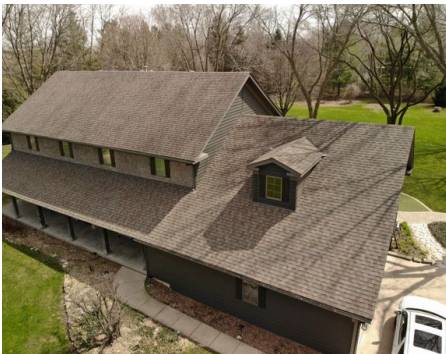
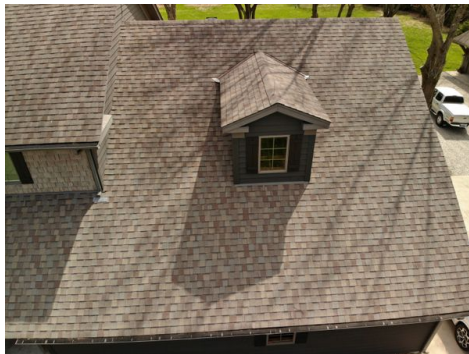
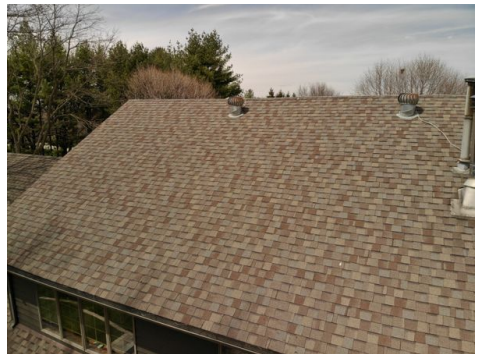
Roof Covering: Roof Was Inspected

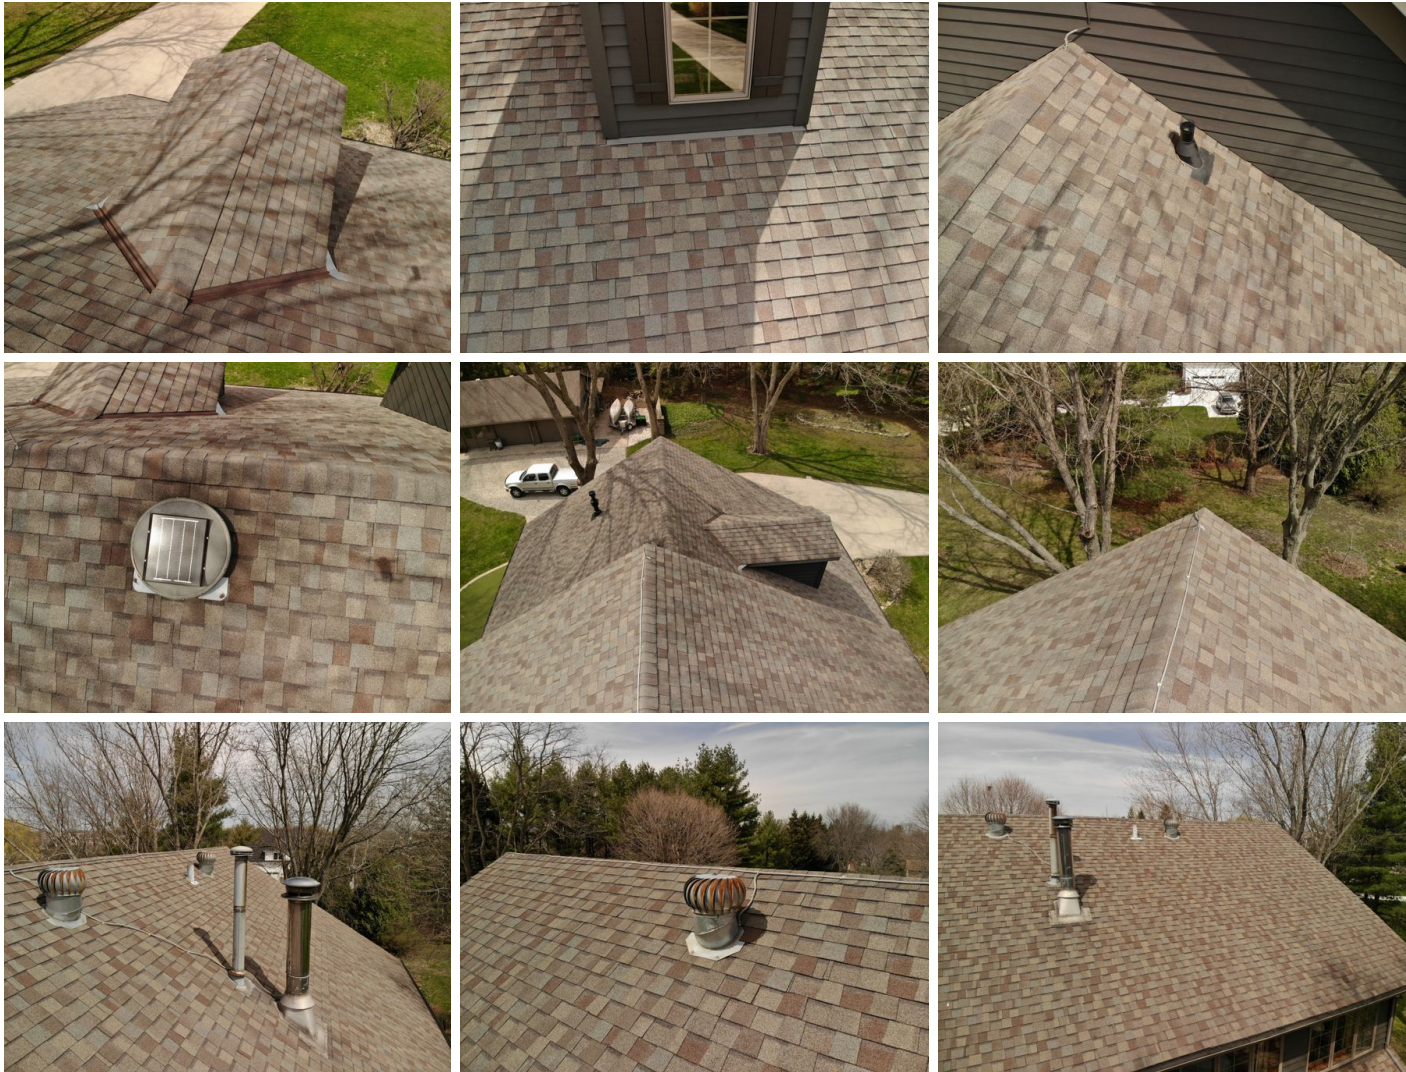
Flashing: Wall Intersections

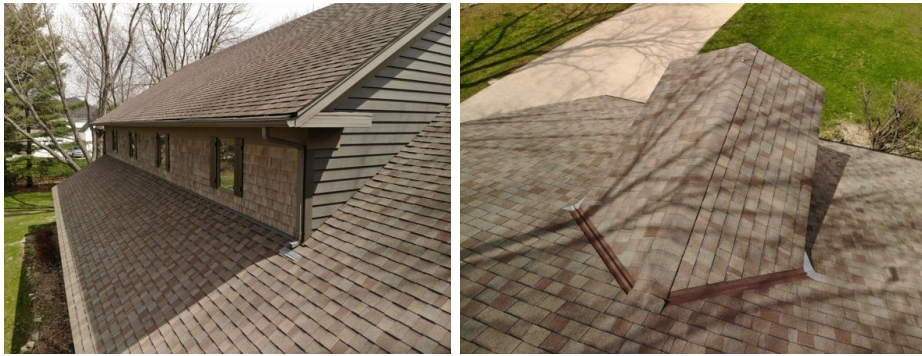
## Plumbing Vent Pipes: Homeowner's Responsibility

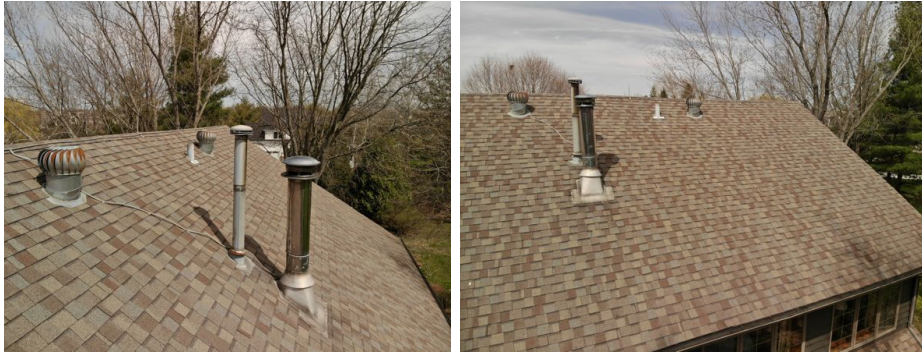
## Gutters & Downspouts: Homeowner's Responsibility

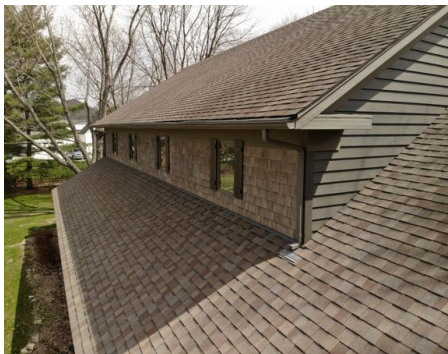
Monitoring the gutters during a heavy rain (without lightening) is recommended. In general, the gutters should catch rain water and direct the water towards downspouts that discharge the water away from the house foundation.

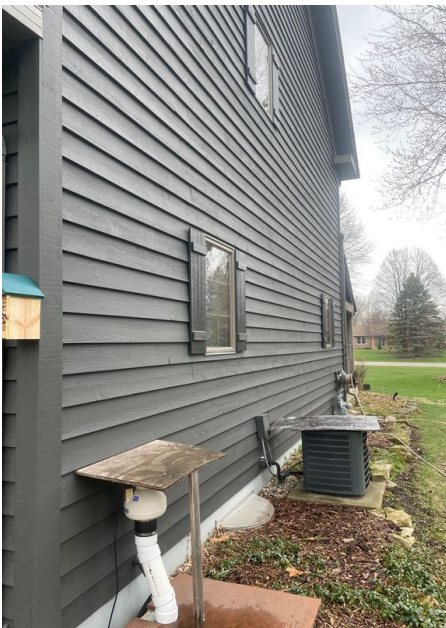
## Vegetation, Surface Drainage, Retaining Walls & Grading: Vegetation, Drainage, Walls & Grading Were Inspected

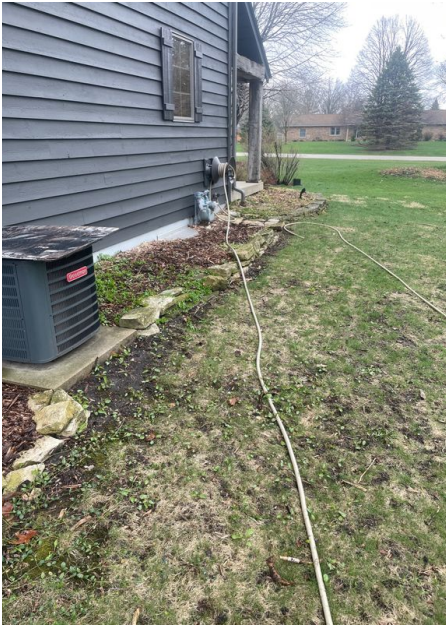
## GFCIs & Electrical: Inspected GFCIs

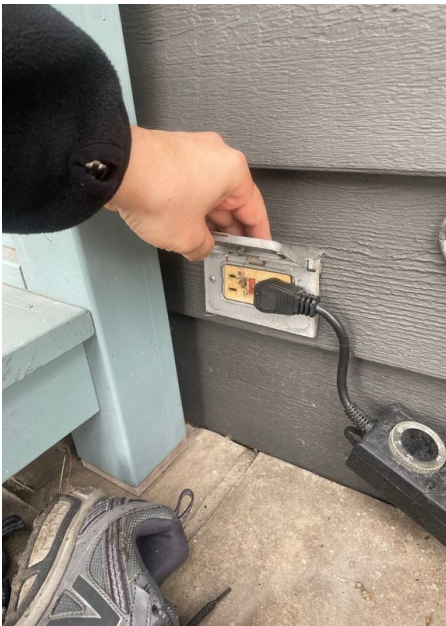
### Walkways & Driveways: Walkways & Driveways Were Inspected

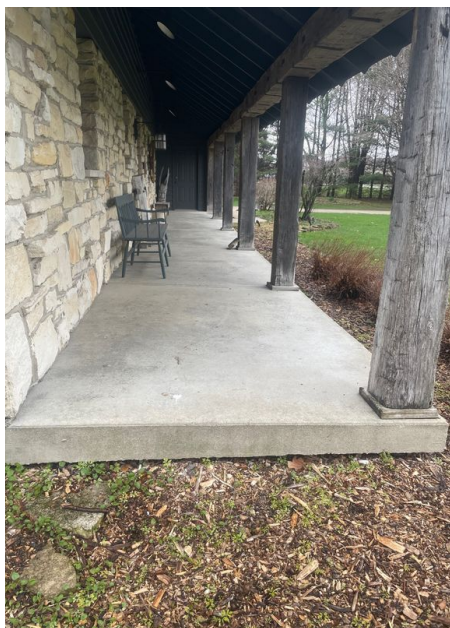
### Stairs, Steps, Stoops, Stairways & Ramps: Stairs, Steps, Stoops, Stairways & Ramps Were Inspected

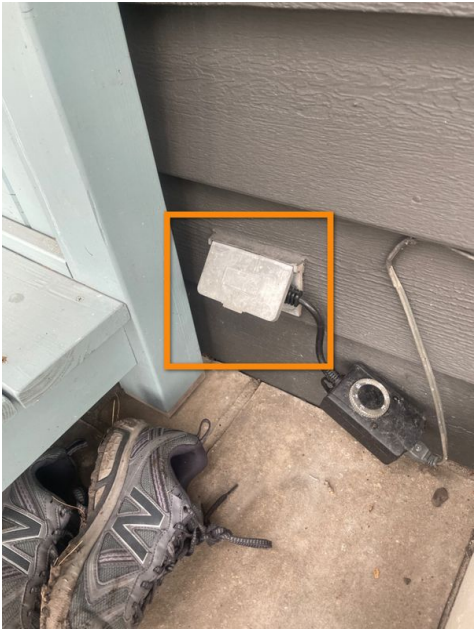
# 5: BASEMENT, FOUNDATION, CRAWLSPACE & STRUCTURE

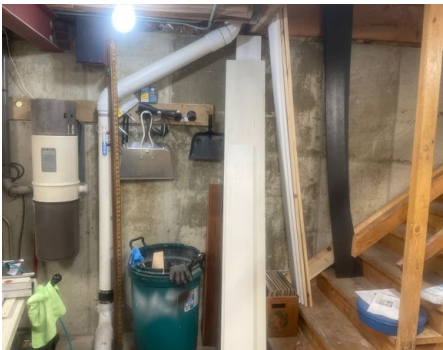
**Insulation in Foundation/Basement Area: Type of Insulation Observed**  
Cellulose, Batt

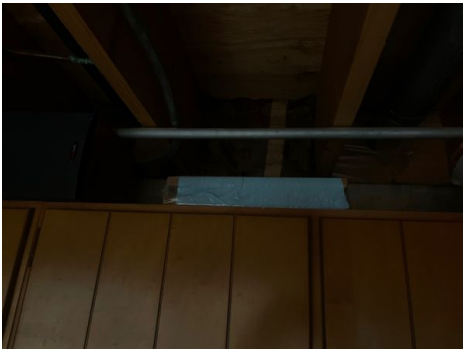
**Basement: Homeowner's Responsibility**

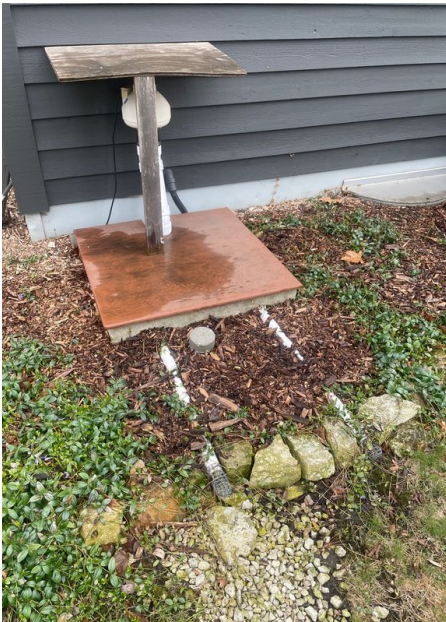
## Sump Pump: Battery backup for sump pump

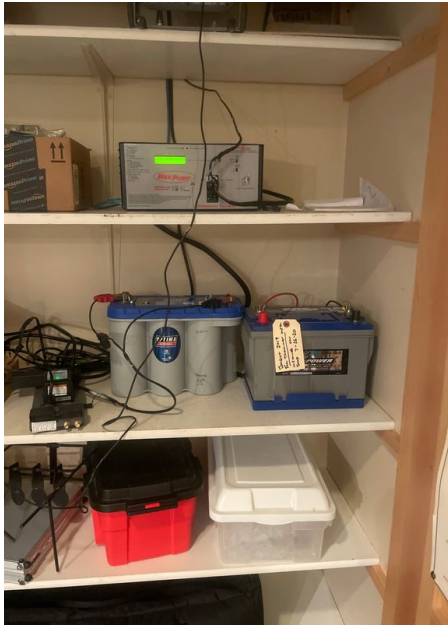
A battery back of system for the sump pump was observed. These are highly recommended and a great addition to your home.

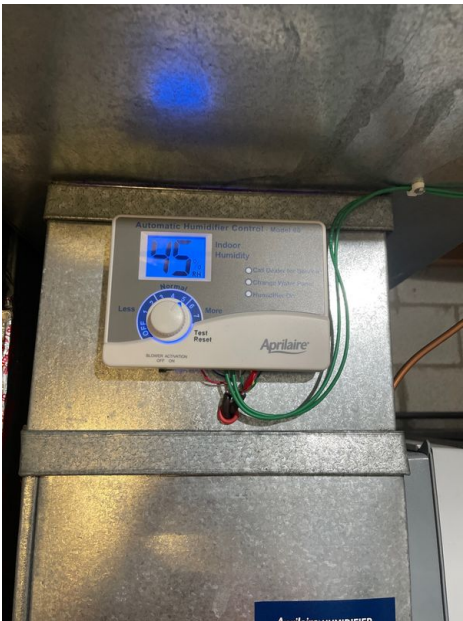
## Heating System Information: Homeowner's Responsibility

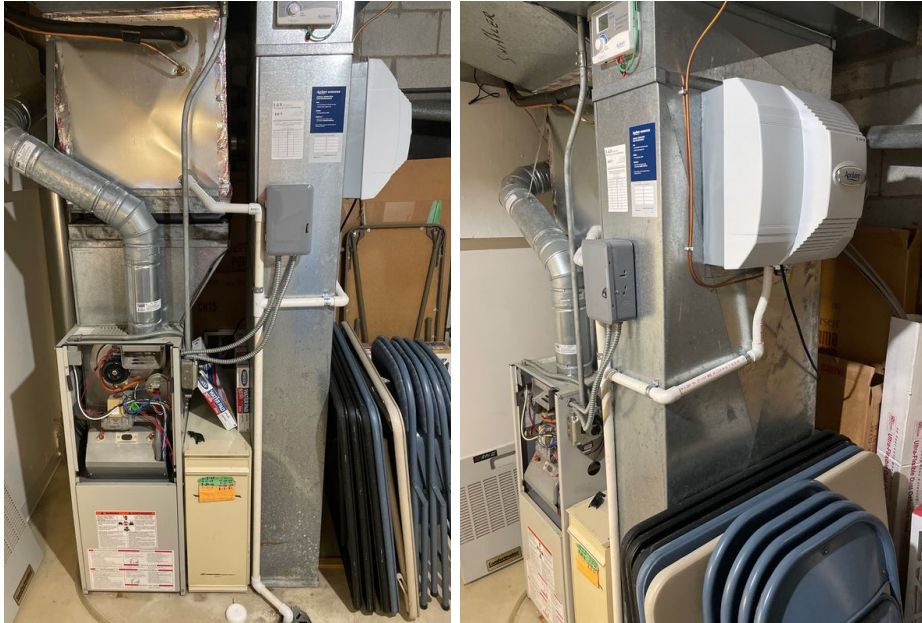
## Thermostat and Normal Operating Controls: Service Switch Inspected

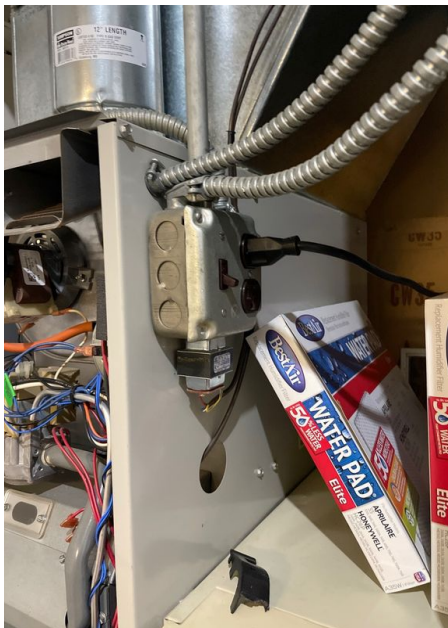
I observed a service switch. I inspected it. It worked when I used it during my inspection.

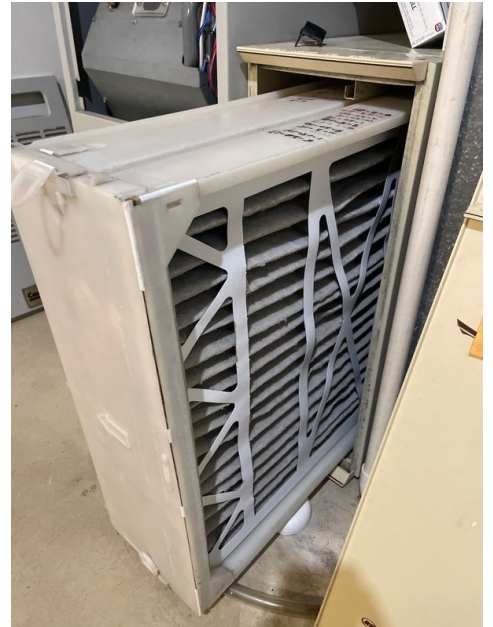
#### 6.4.1 Humidifier

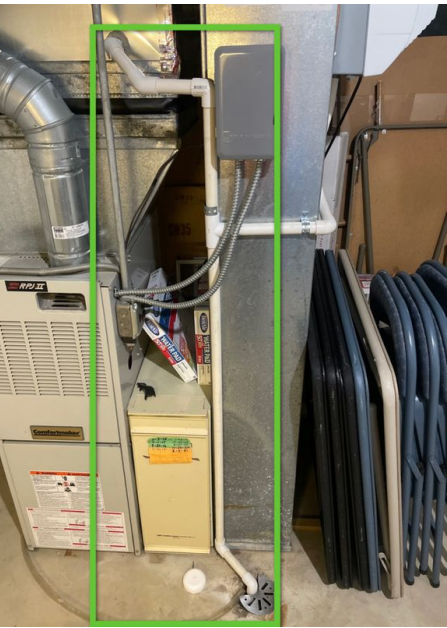
## Outdoor Unit: Condenser Unit Inspected

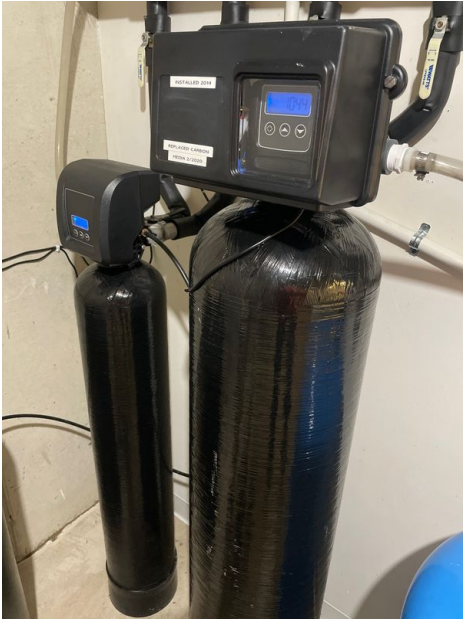
**Main Water Shut-Off Valve: Homeowner's Responsibility**

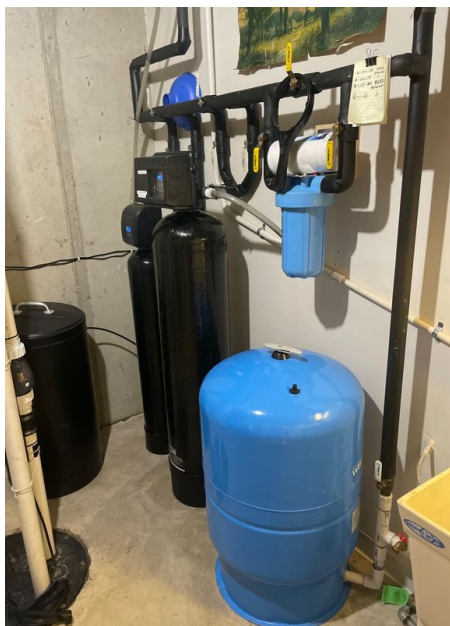
## Hot Water Source: Type of Hot Water Source

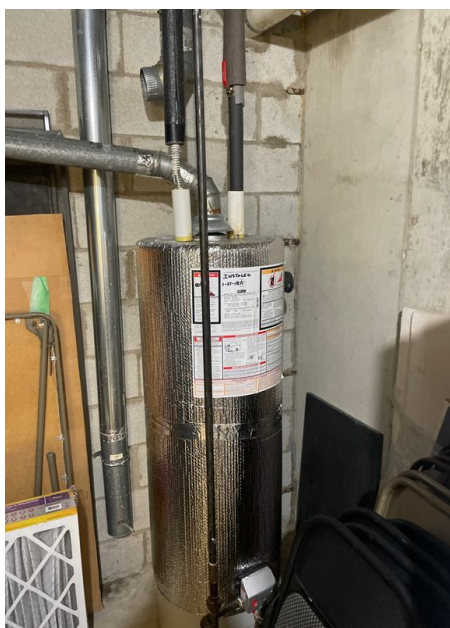
## Hot Water Source: Inspected Hot Water Source

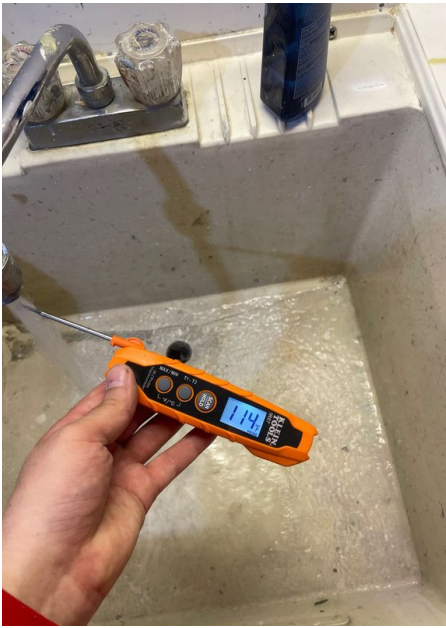
**Drain, Waste, & Vent Systems: Inspected Drain, Waste, Vent Pipes**

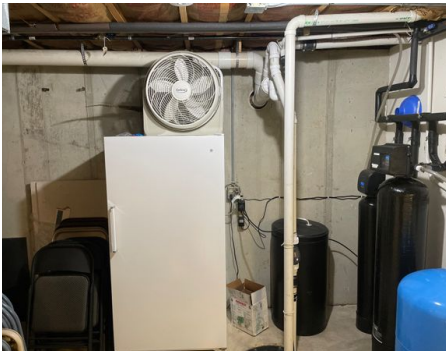
**Water Supply & Distribution Systems: Inspected Water Supply & Distribution Pipes**

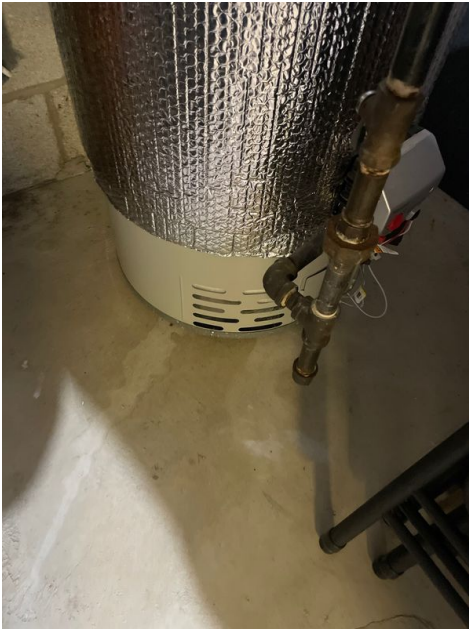
#### 8.3.2 Hot Water Source

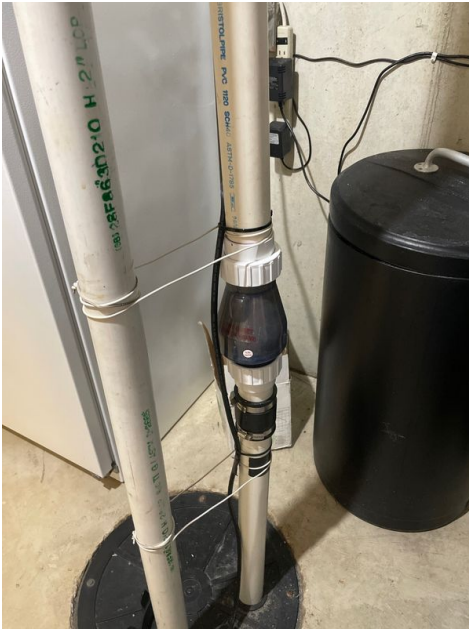
### 8.5.1 Water Supply & Distribution Systems

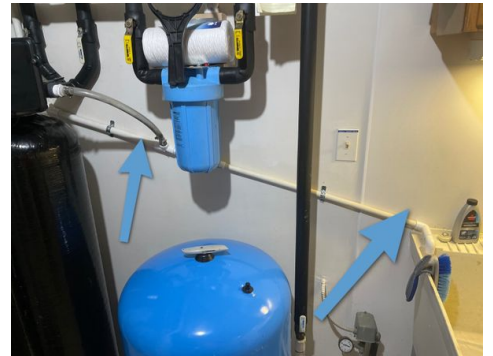
Contact a qualified professional.

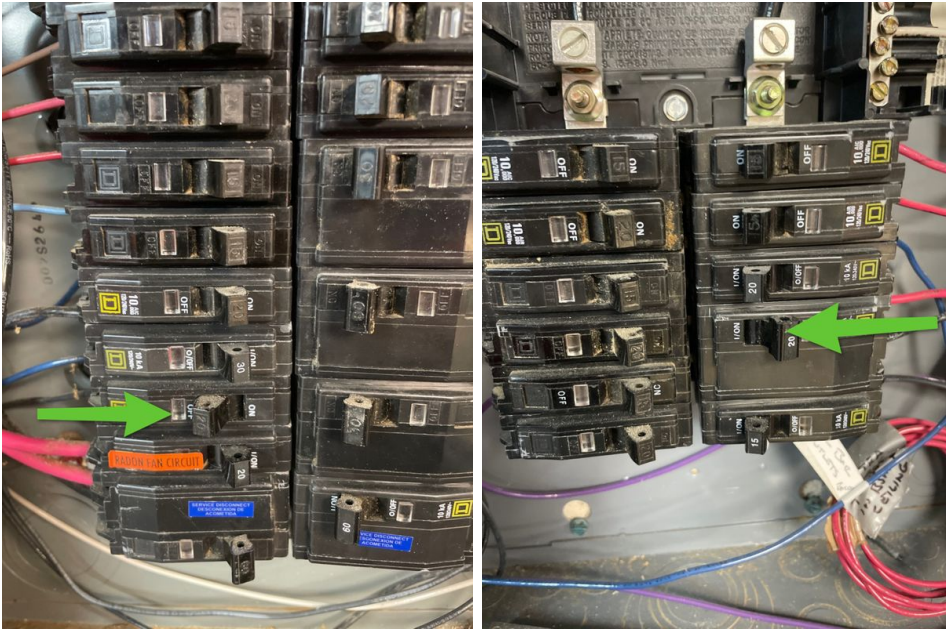
I observed a breaker in the "off" position prior to inspecting the electrical panel. Recommend asking the homeowner what this breaker is connected to, and why it is off.

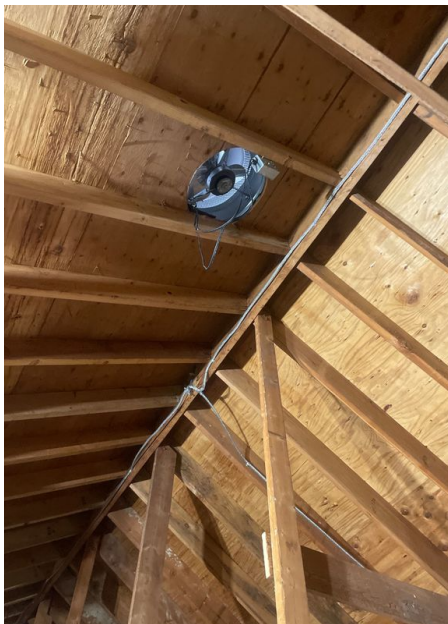
Ventilation in Attic: Whole House Fan

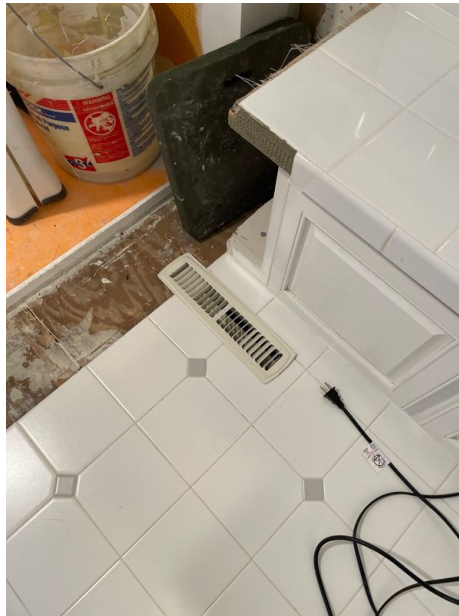
### Cabinetry, Ceiling, Walls & Floor: Cabinetry Inspected

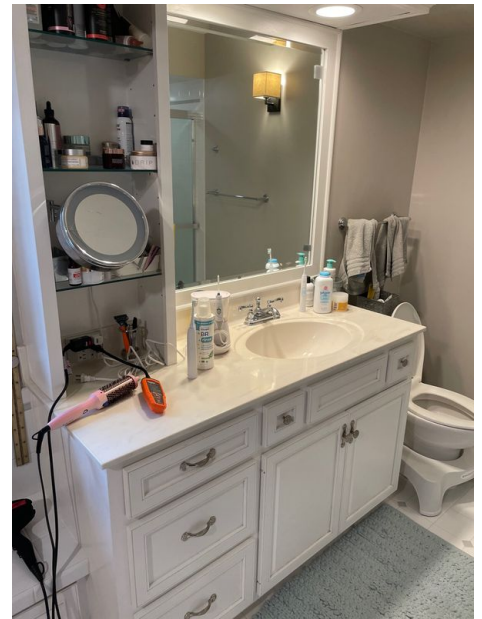
### Door: Door Construction

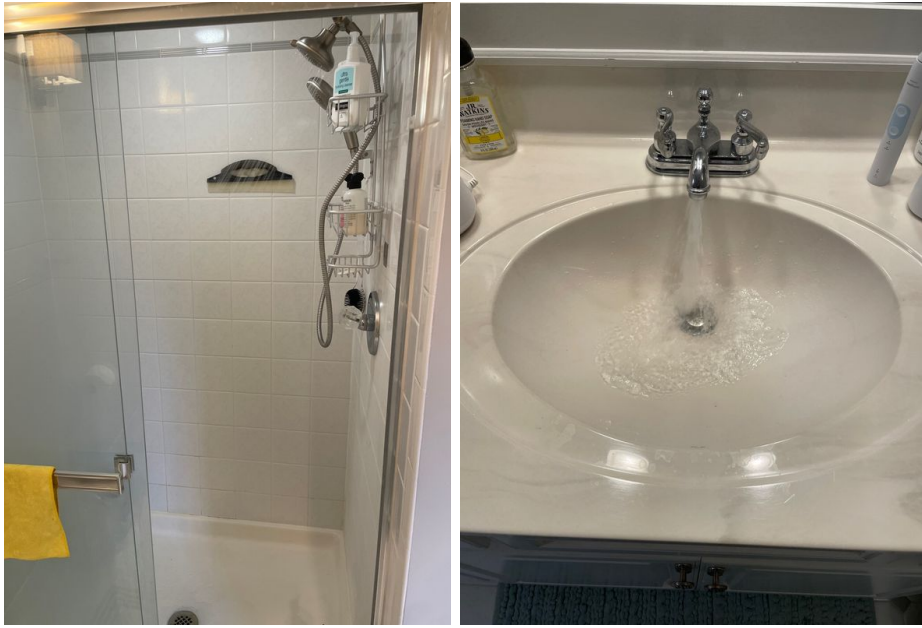
## Bathroom Exhaust Fan / Window: Inspected Bath Exhaust Fans

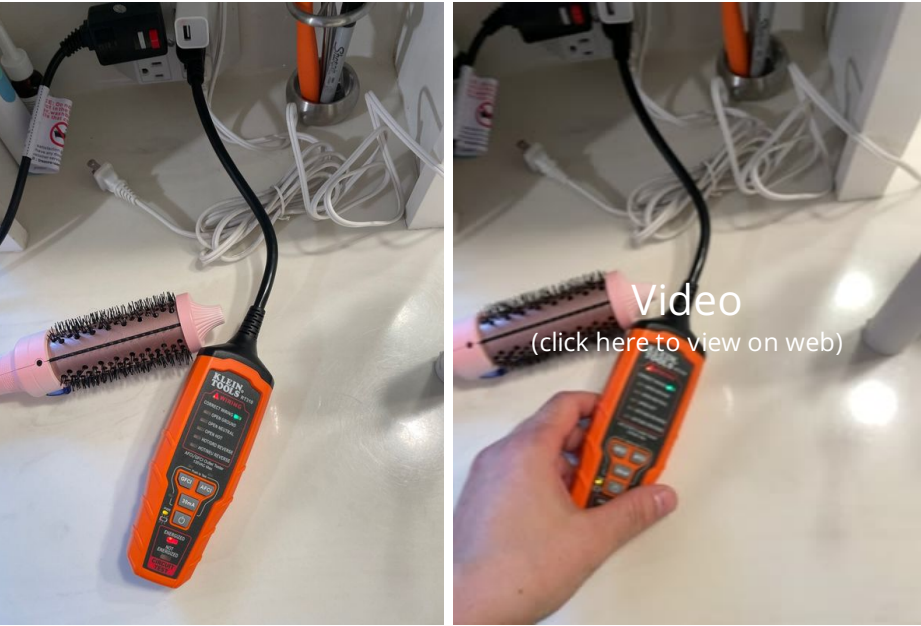
**Door: Doors Inspected**

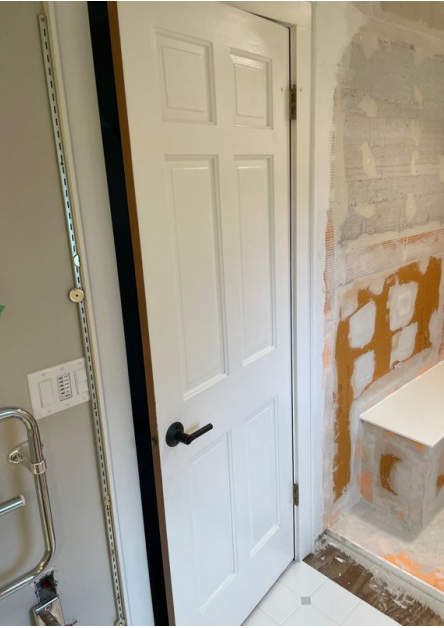
Doors were inspected and found to be in good operating condition. All locks were verified to work where applicable.

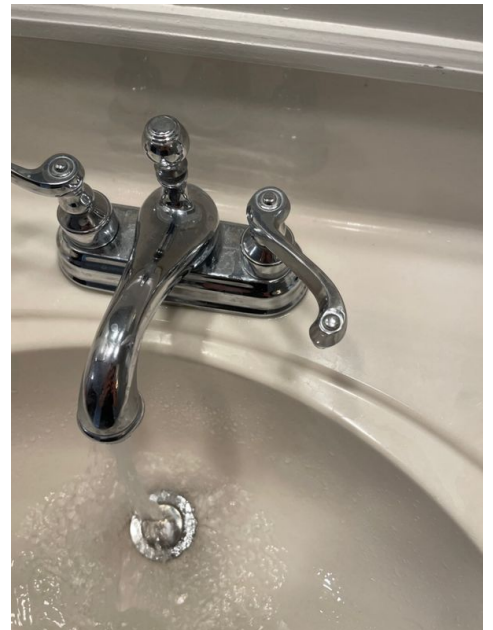
## 12: HALL BATHROOM

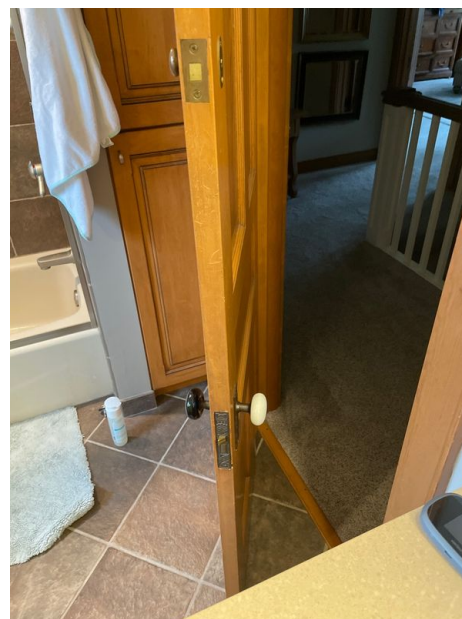
#### Sinks, Tubs & Showers: Ran Water at Sinks, Tubs & Showers

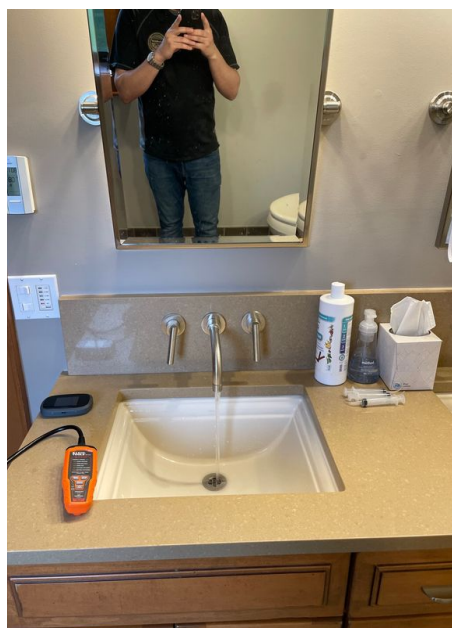
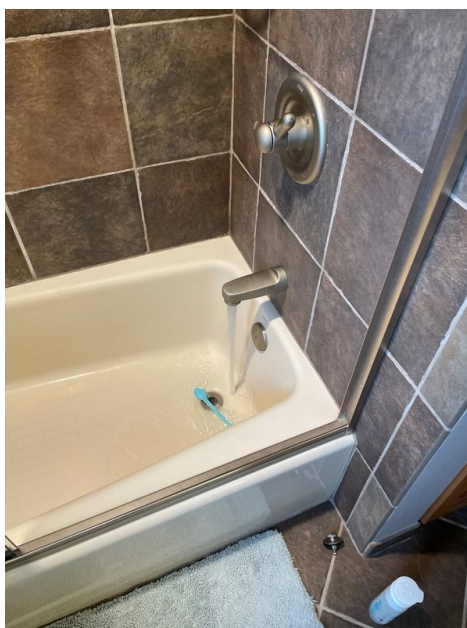
### Bathroom Exhaust Fan / Window: Inspected Bath Exhaust Fans

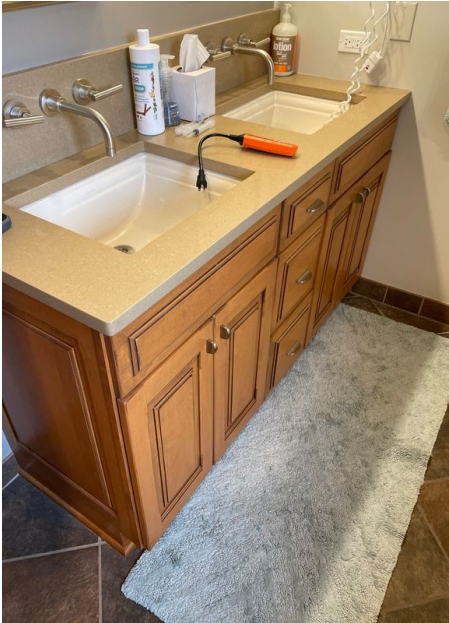
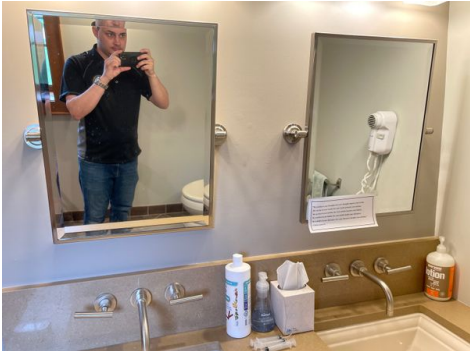
Door: Doors Inspected

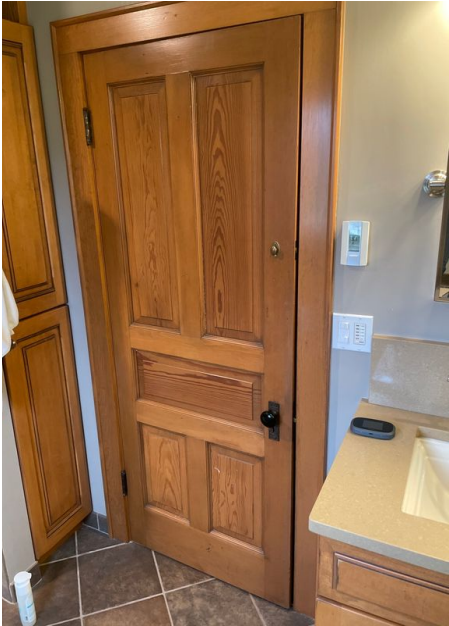
Doors were inspected and found to be in good operating condition. All locks were verified to work where applicable.

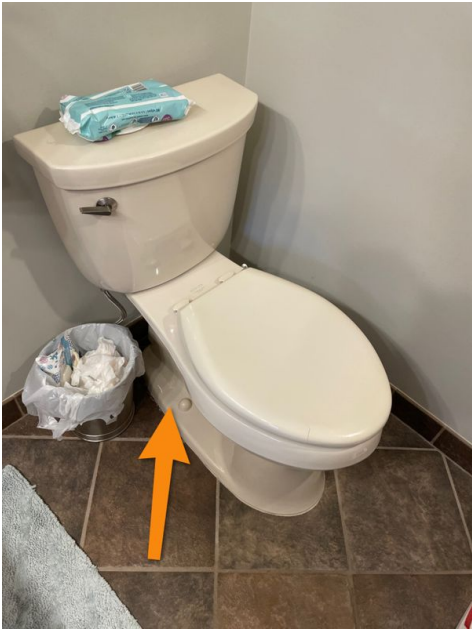
# 13: POWDER ROOM BATHROOM

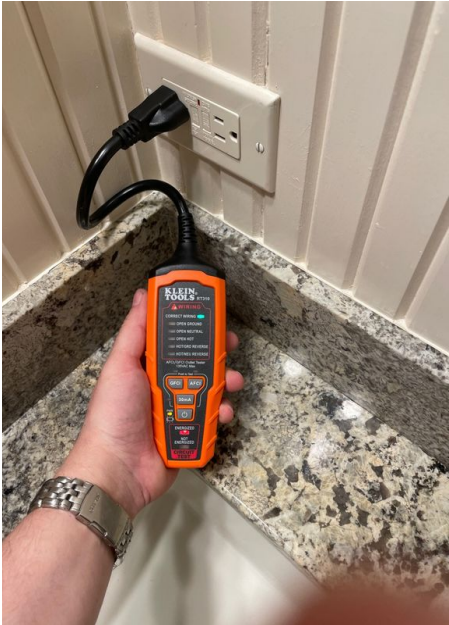
**Cabinetry, Ceiling, Walls & Floor: Cabinetry Inspected**

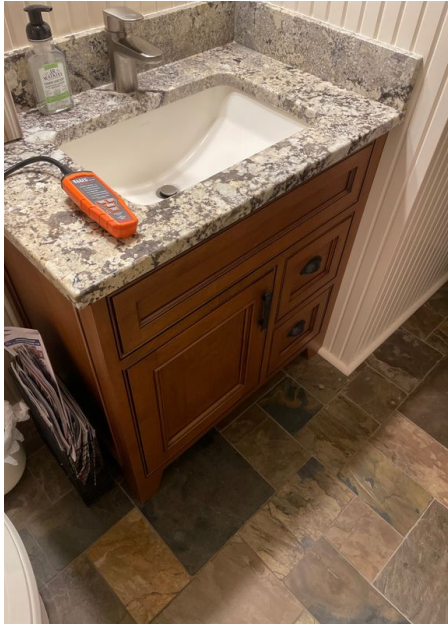
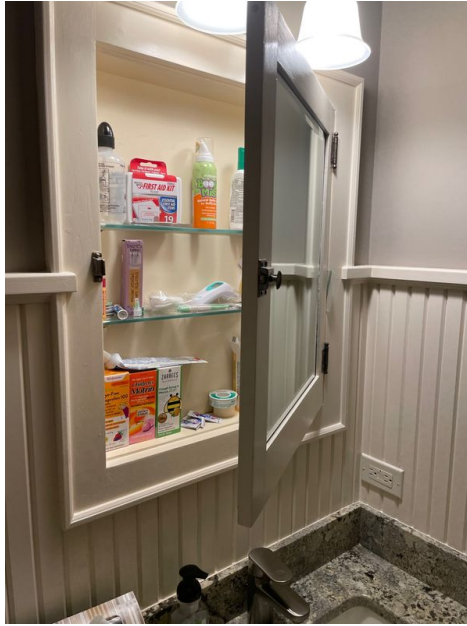
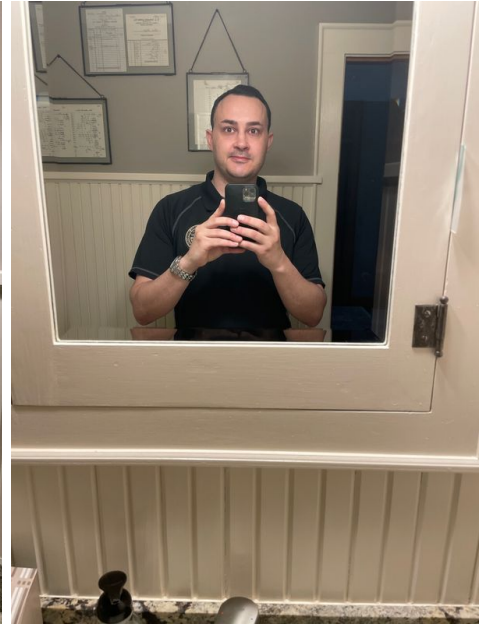
**Door: Doors Inspected**

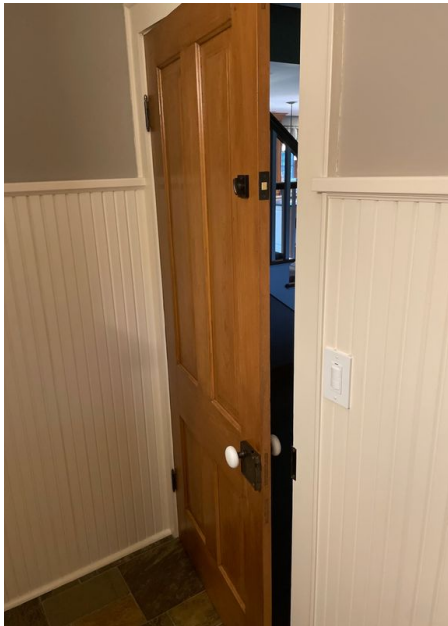
# 14: BASEMENT BATHROOM

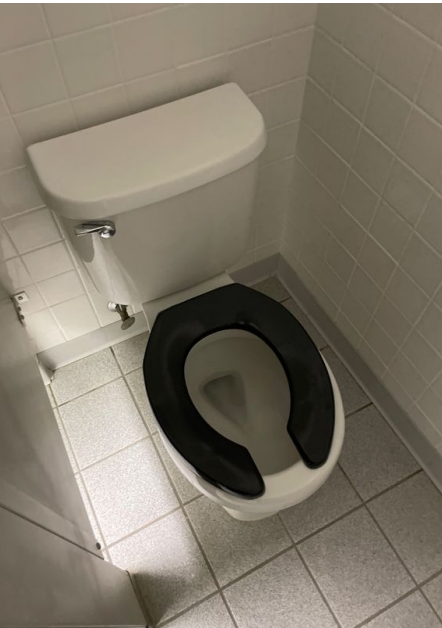
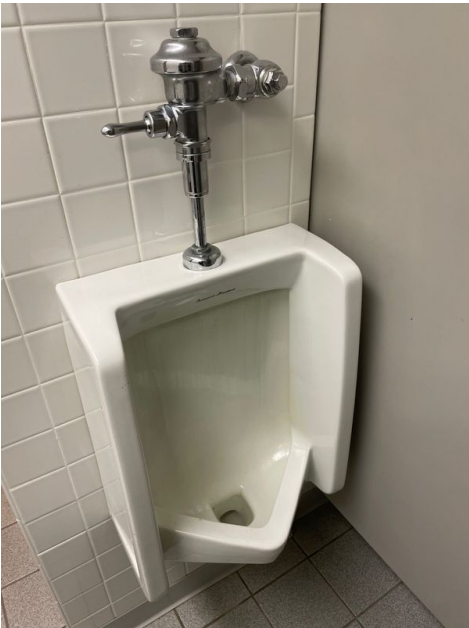
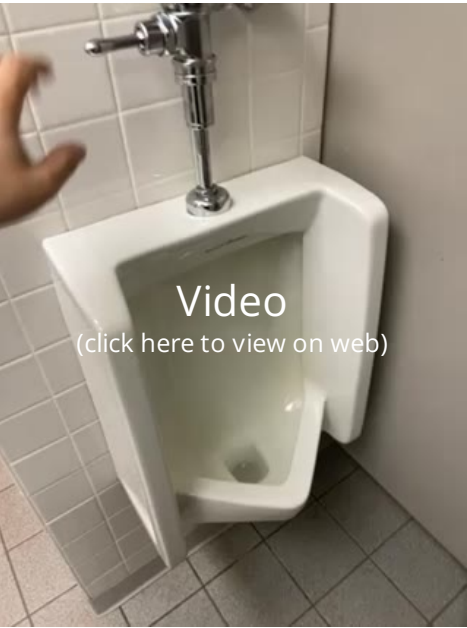
### Sinks, Tubs & Showers: Ran Water at Sinks, Tubs & Showers

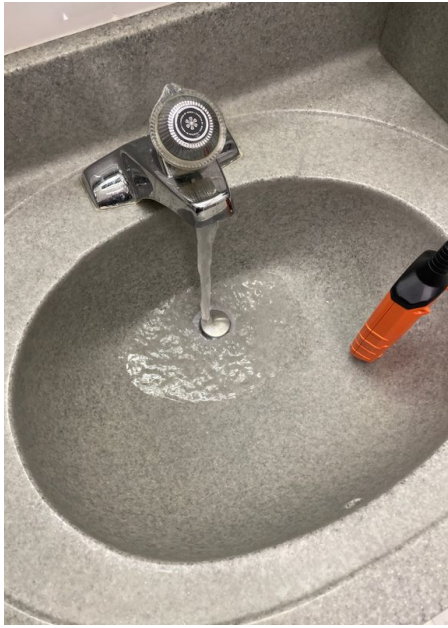
### Bathroom Exhaust Fan / Window: Inspected Bath Exhaust Fans

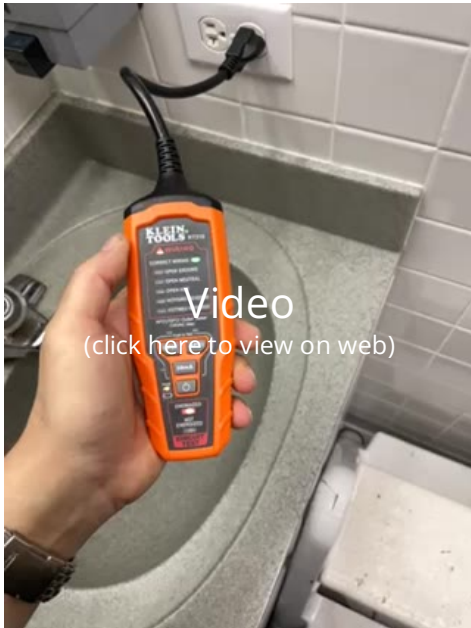
Video  
(click here to view on web)

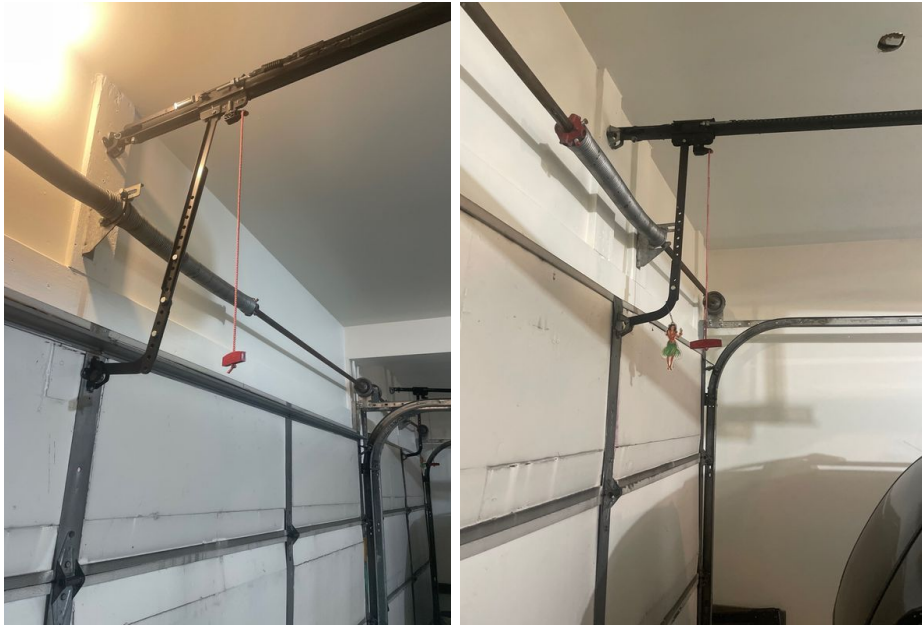
### Garage Vehicle Door Opener: Springs, Bracket & Hardware Were Inspected

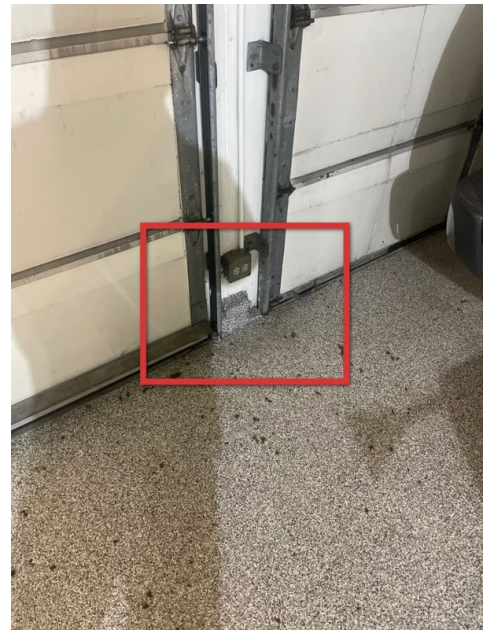
#### 17.4.1 Electric in Garage

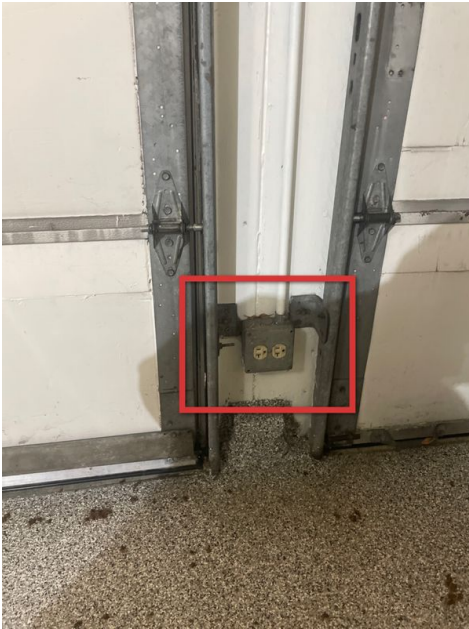
#### 17.4.2 Electric in Garage

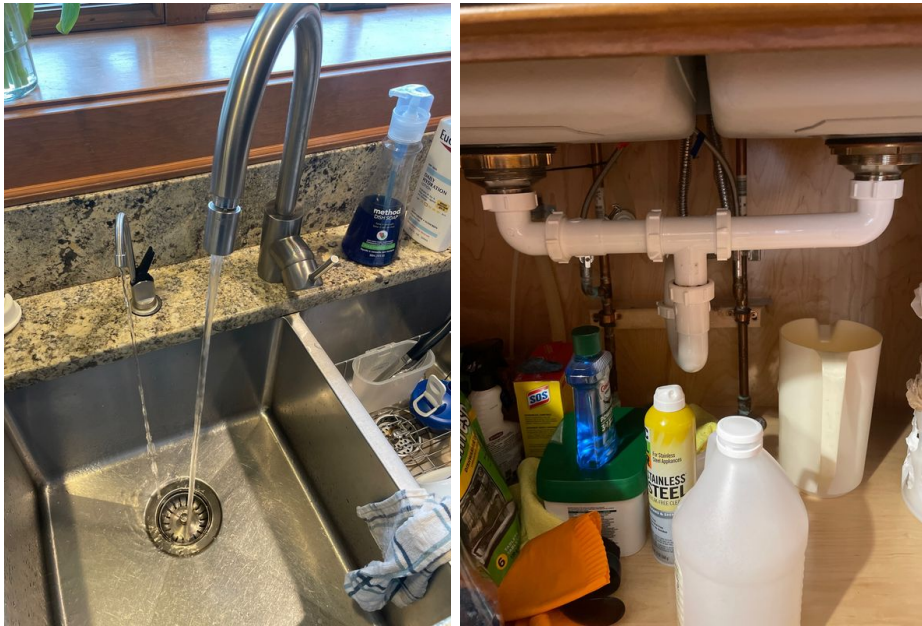
I ran water at the kitchen sink.

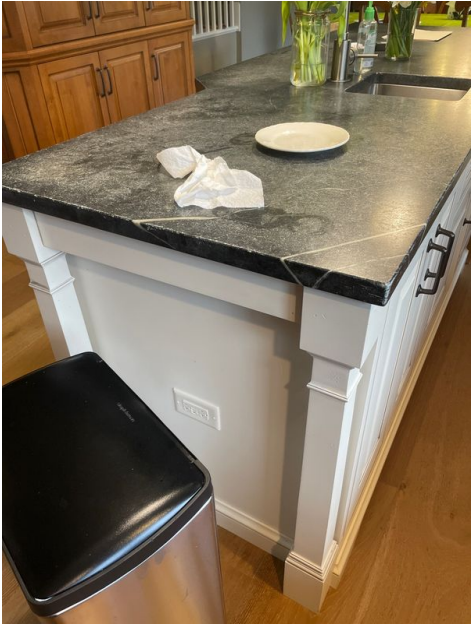
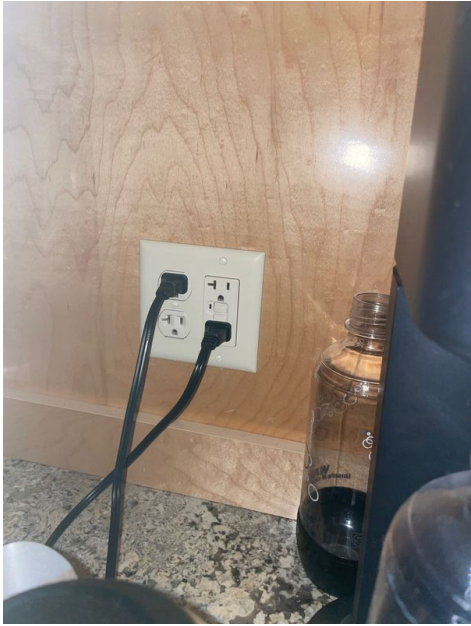
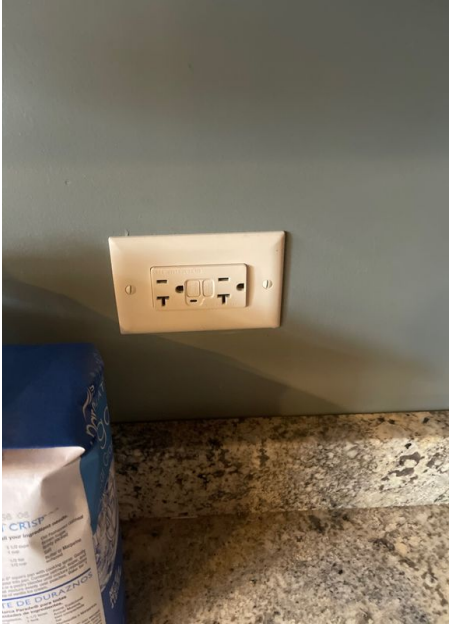
**Dishwasher: Inspected Dishwasher**

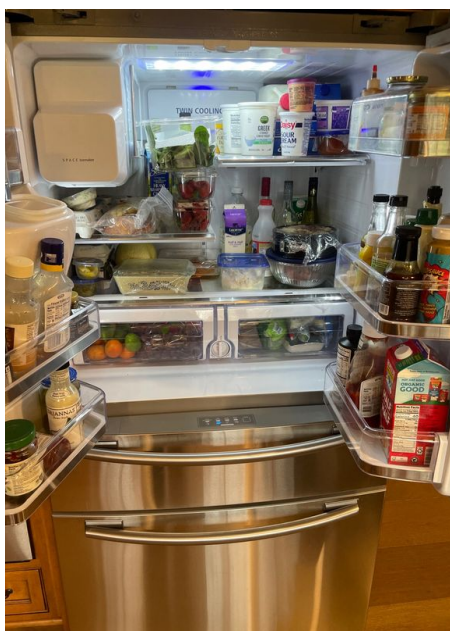
### Built-in Microwave: Microwave Turned On

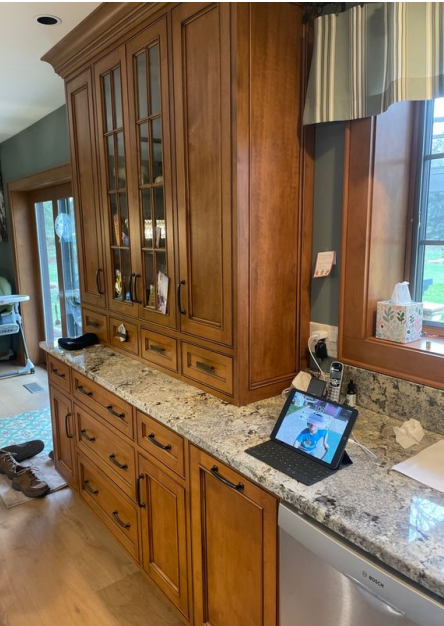
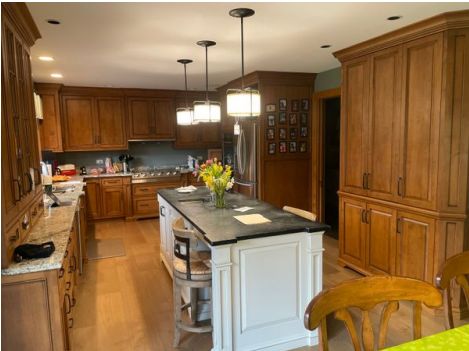
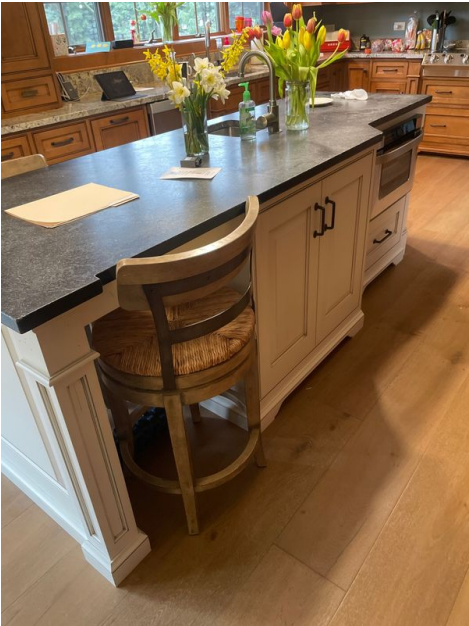
**Floors, Walls, Ceilings: Floors, Walls, Ceilings Inspected**
